CULTURAL RESOURCE SURVEY
SECONDARY BUILDING FORM

Name: Cochran Grange; John P.
Cochran House

CRS No. N00118

CRS No. N00121

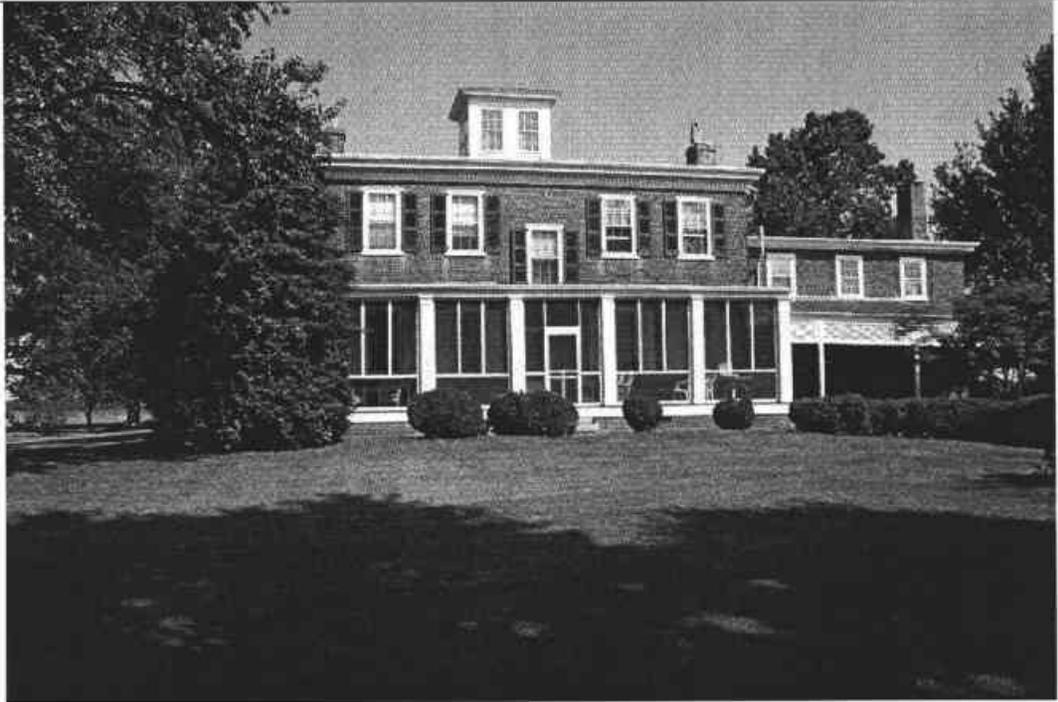
N00117. Photograph 1: Rear (east) elevation of dwelling, view to northwest.

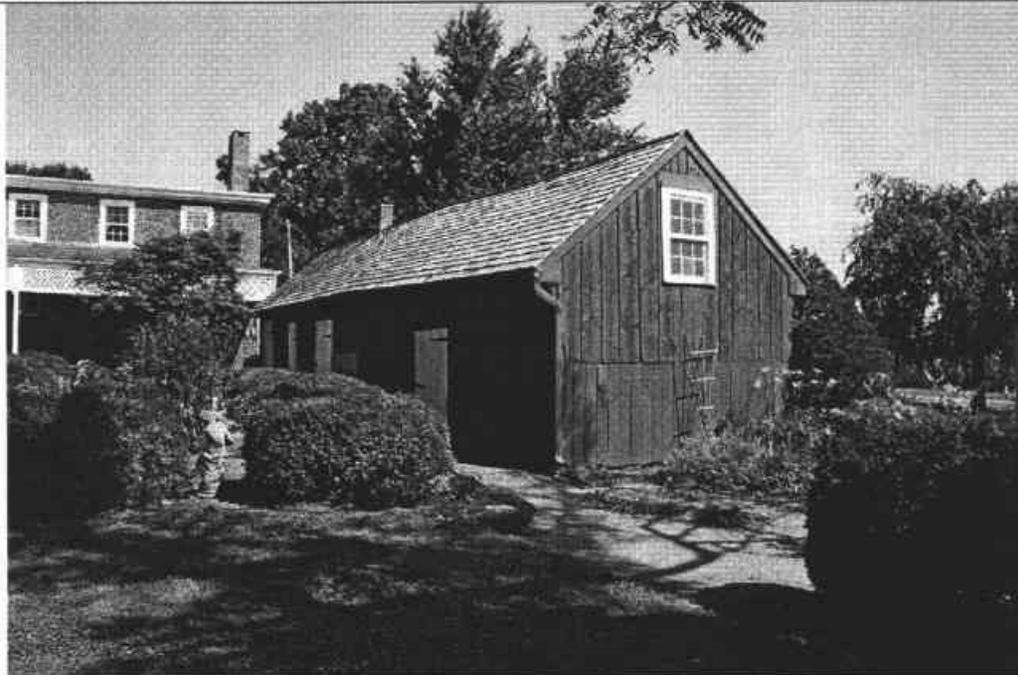
N00117. Photograph 2: Brick slave quarters, south and east elevations, view to northwest.

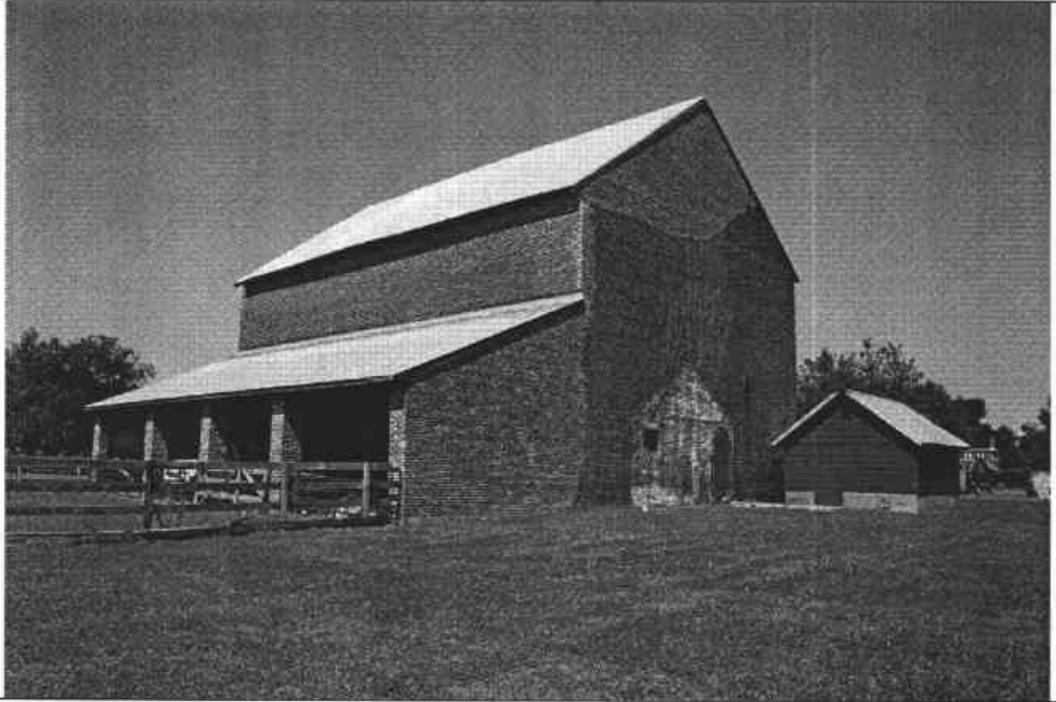
N00117. Photograph 3: Brick bank barn and frame milk house, east and north elevations, view to southwest.

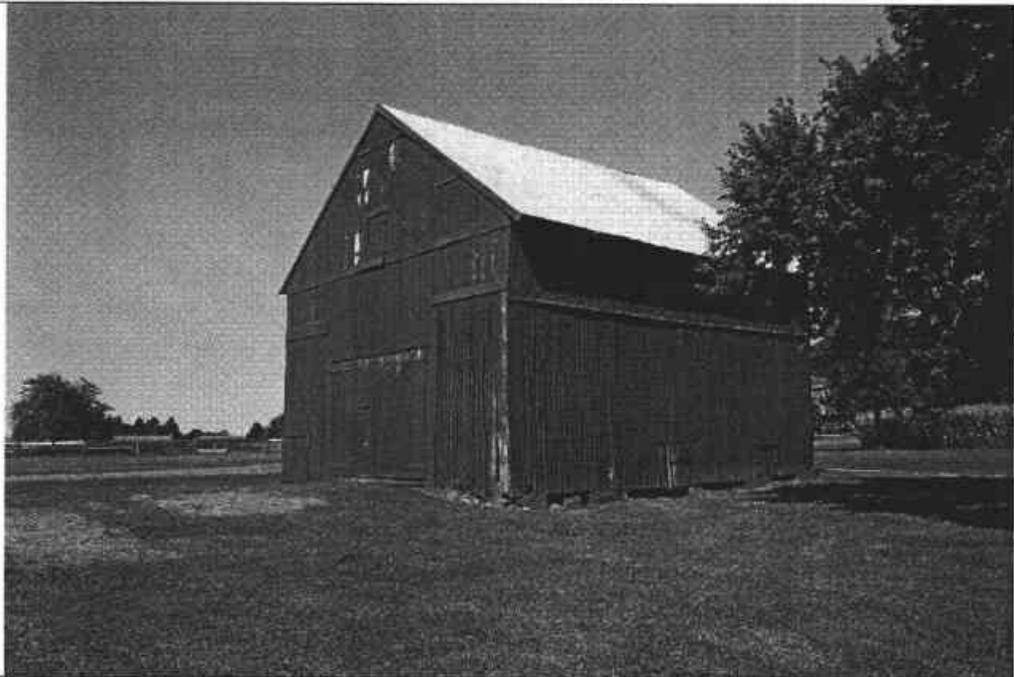
N00117. Photograph 4: Corncrib/granary, east and north elevations, view to southwest.

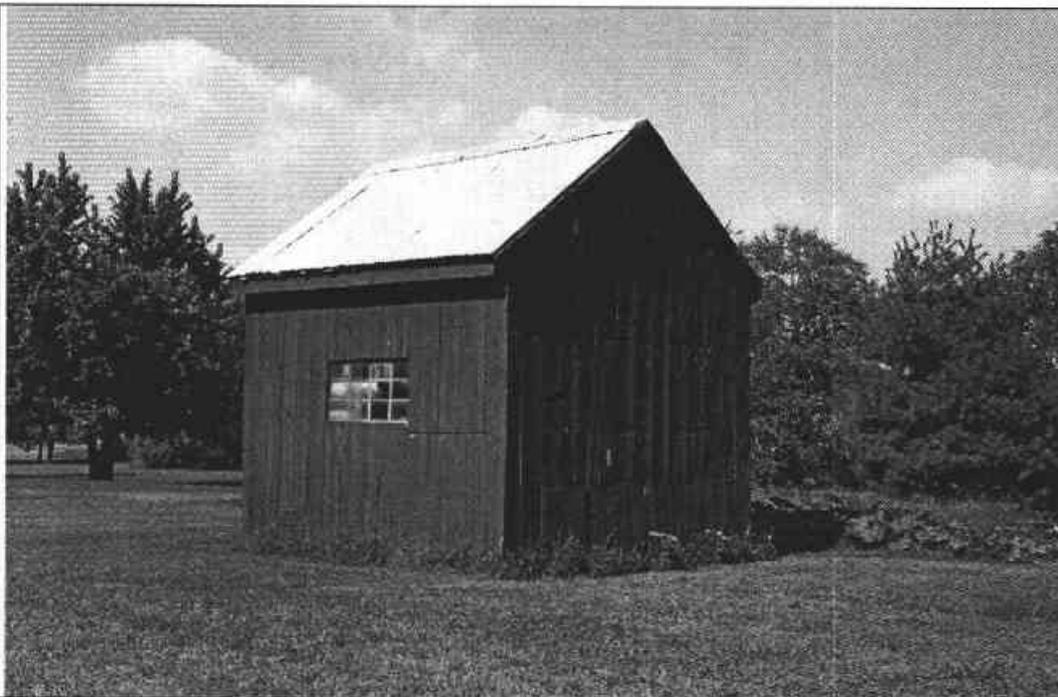
N00118. Photograph 3. Smokehouse, view looking southeast.

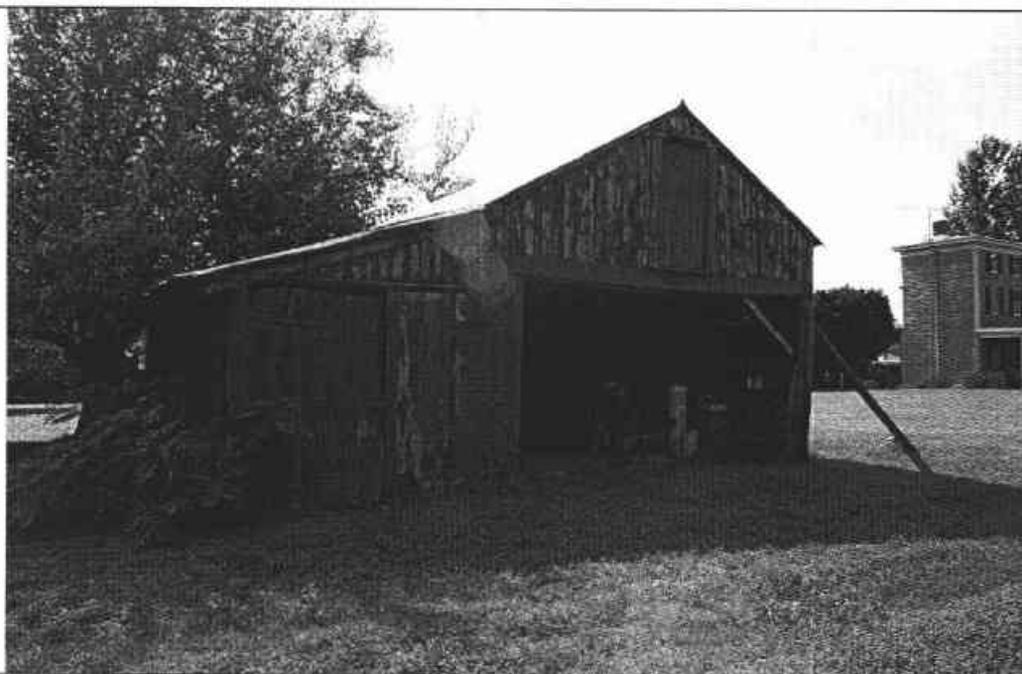
N00118. Photograph 4. Carriage house, view looking northwest.

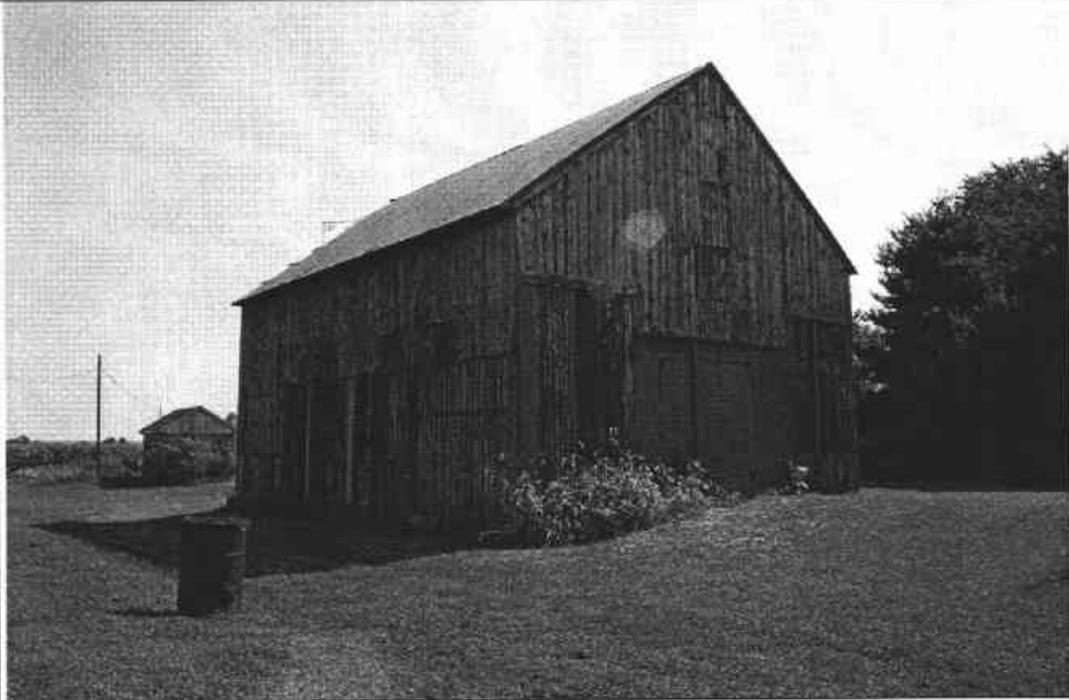
N00118. Photograph 5. Corn crib/granary, view looking south.

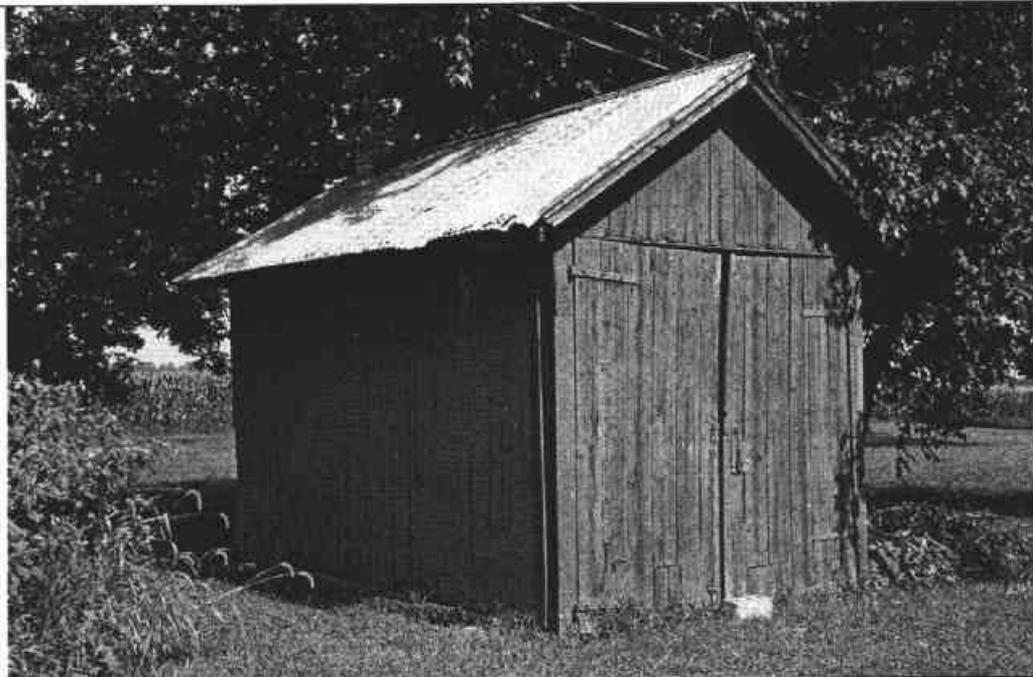
N00118. Photograph 6. Forge house, view looking southeast.

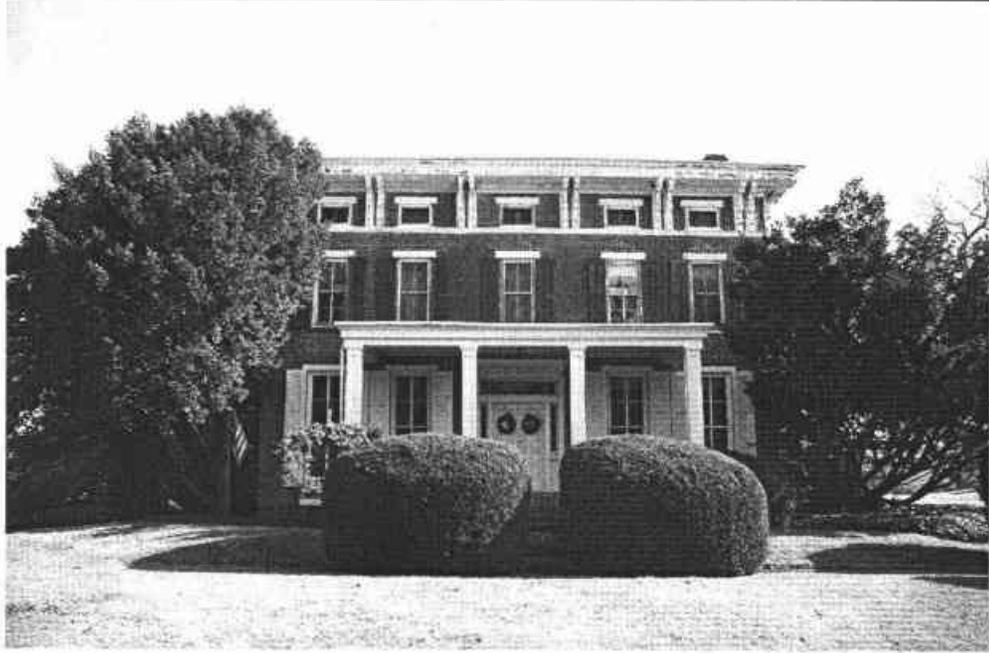
N00121. Photograph 1: Dwelling, 4677 Summit Bridge Road, west elevation, view facing east. Note the retention of integrity of design, workmanship, materials, setting, location, and feeling.

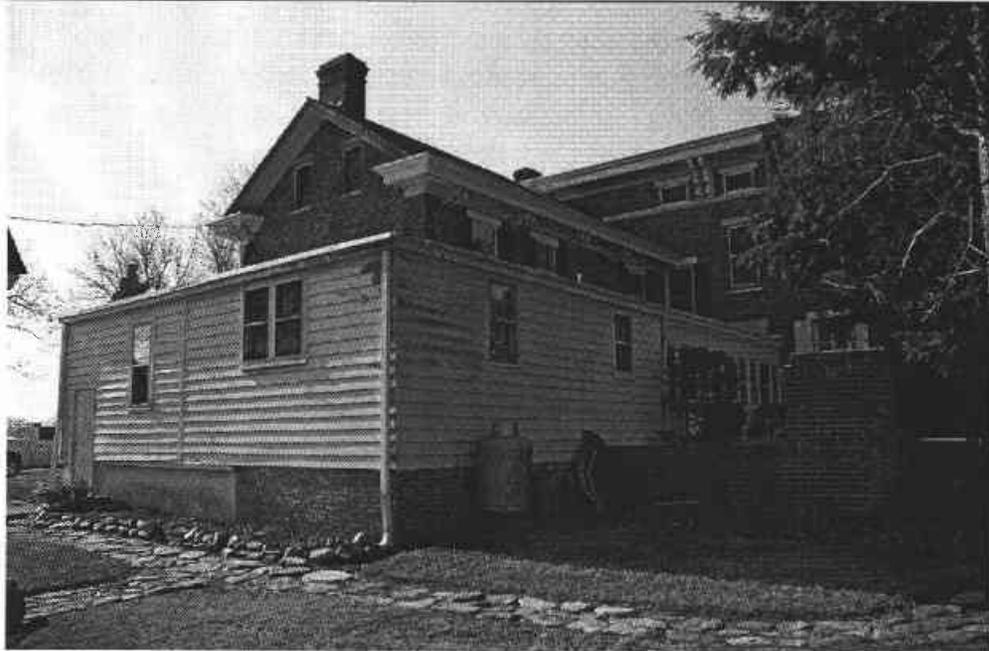
N00121. Photograph 2: Dwelling, 4677 Summit Bridge Road, north and east elevations, view facing southwest. Note the enclosed porch on north and east elevations.

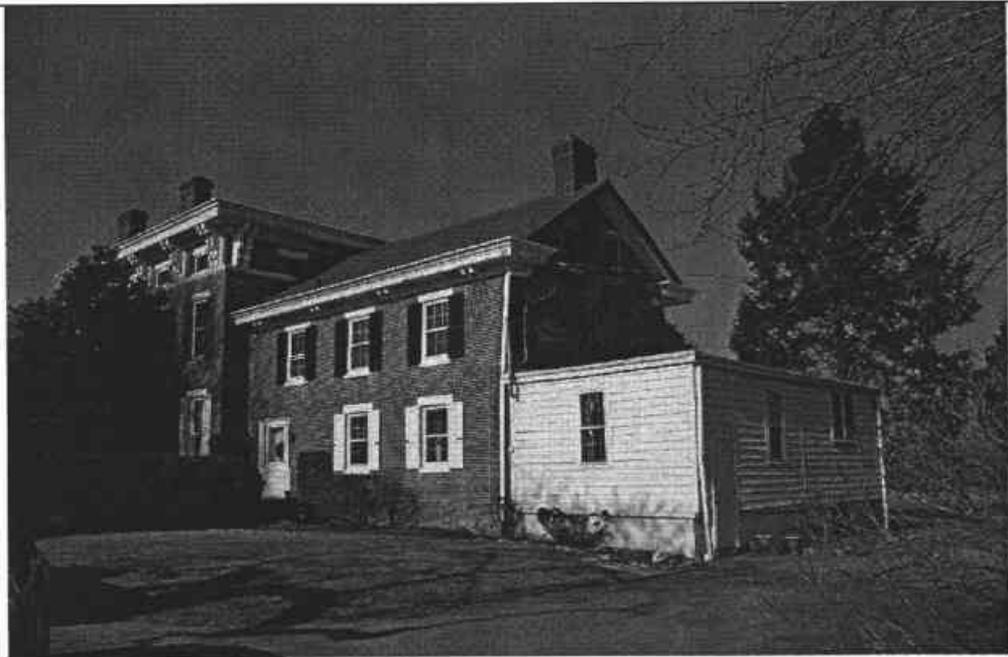
N00121. Photograph 3: Dwelling, 4677 Summit Bridge Road, south and east elevations, view facing northwest. Note the rear ell (*circa*-1835 original block) and enclosed rear porch off of the east elevation.

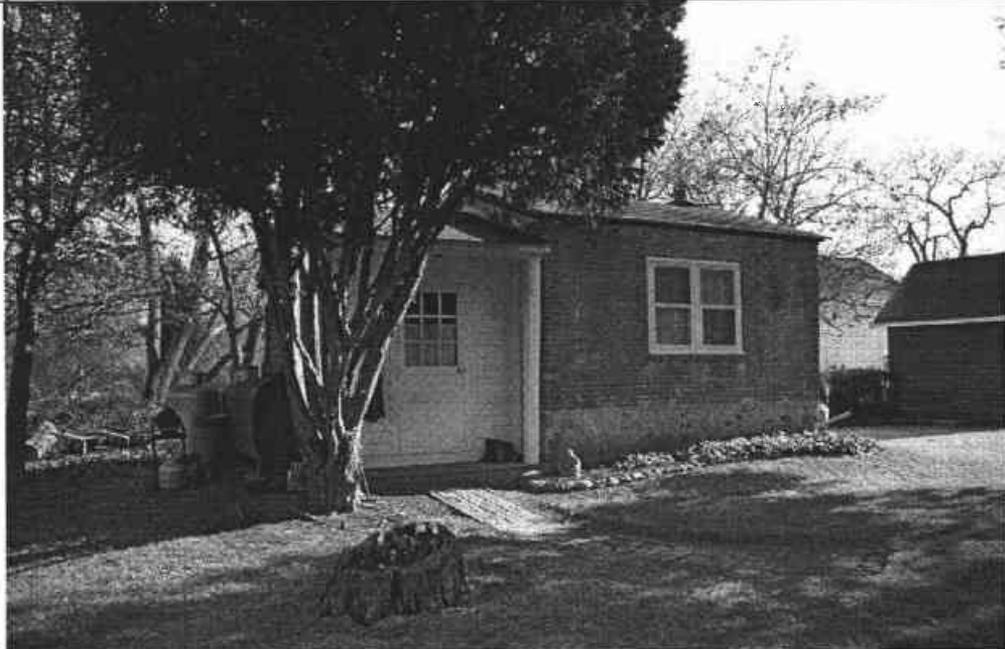
N00121. Photograph 4: Icehouse, 4677 Summit Bridge Road, west elevation, view facing southeast. This building was converted to a guesthouse ca. 1955. Note the north end wooden clapboard enclosure and modern windows.

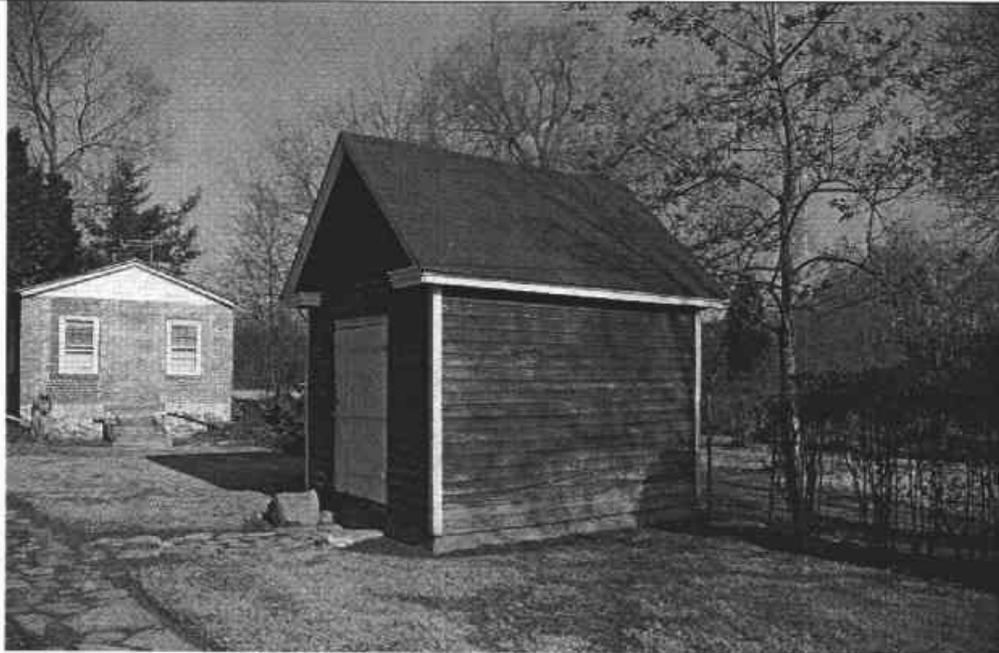
N00121. Photograph 5: Tool shed (former smokehouse), 4677 Summit Bridge Road, south and west elevations, view facing northeast. South elevation of icehouse located in background.

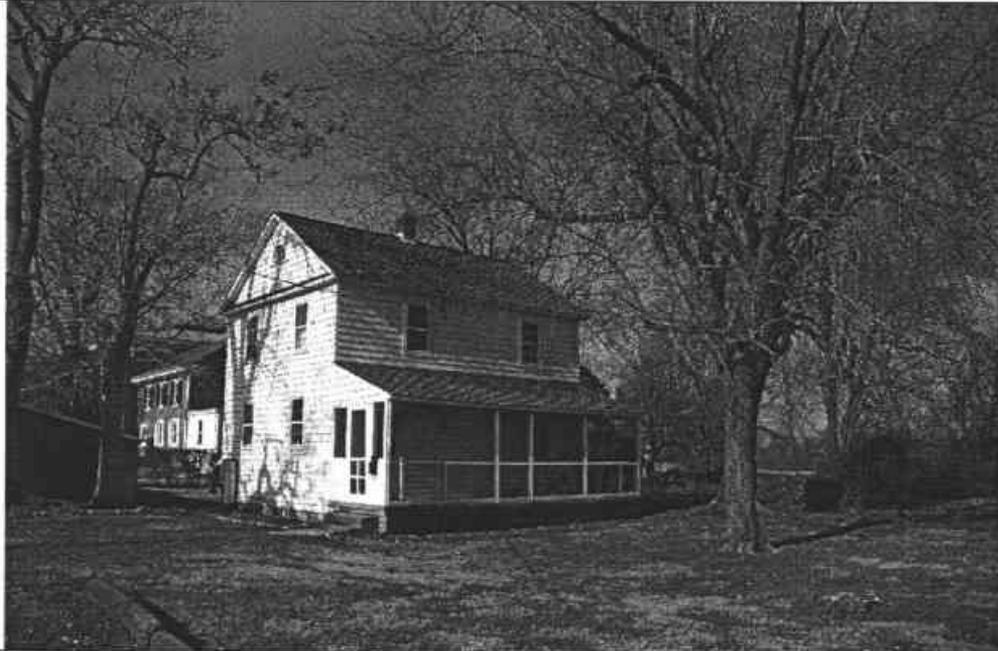
N00121. Photograph 6: Tenant House, 4677 Summit Bridge Road, south and east elevations, view facing northwest. Note the screened-in front porch on east elevation and return gable on south elevation.

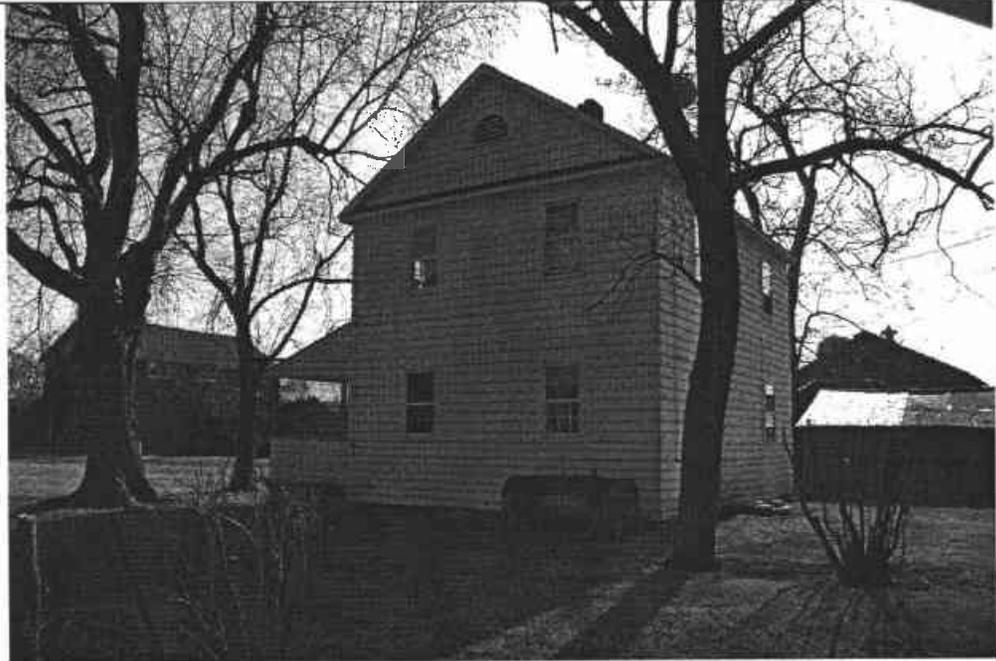
N00121. Photograph 7: Tenant House, 4677 Summit Bridge Road, north and west elevations, view facing southwest. Note return gable on north elevation. Note corncrib/granary to left and cart shed and barn to right of photograph.

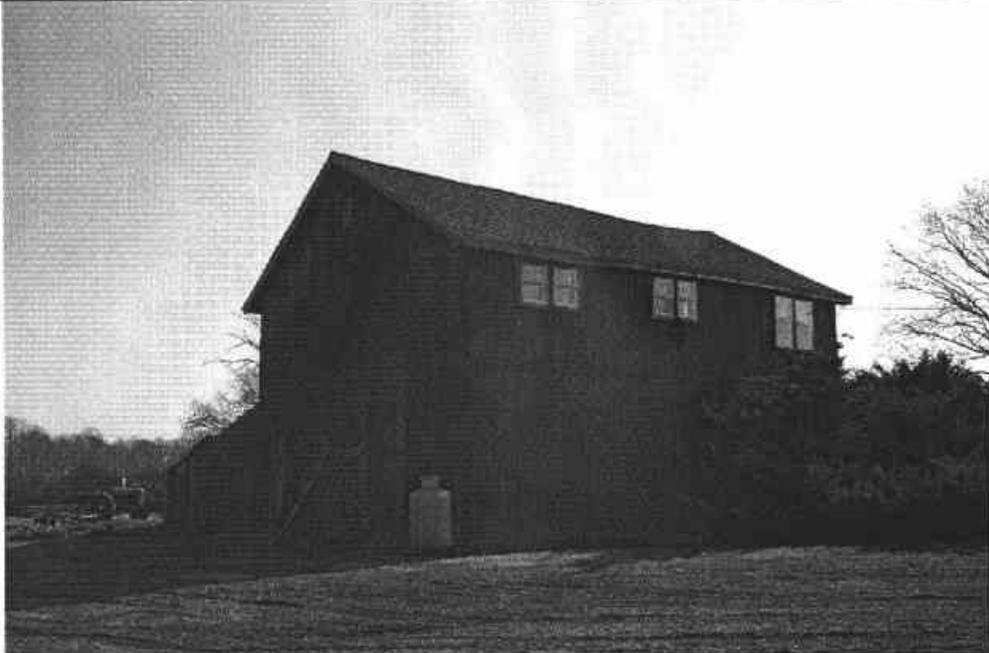
N00121. Photograph 8: Corncrib/Granary, 4677 Summit Bridge Road, north and west elevations, view facing southeast. Note the modern windows at upper level where there is now living space.

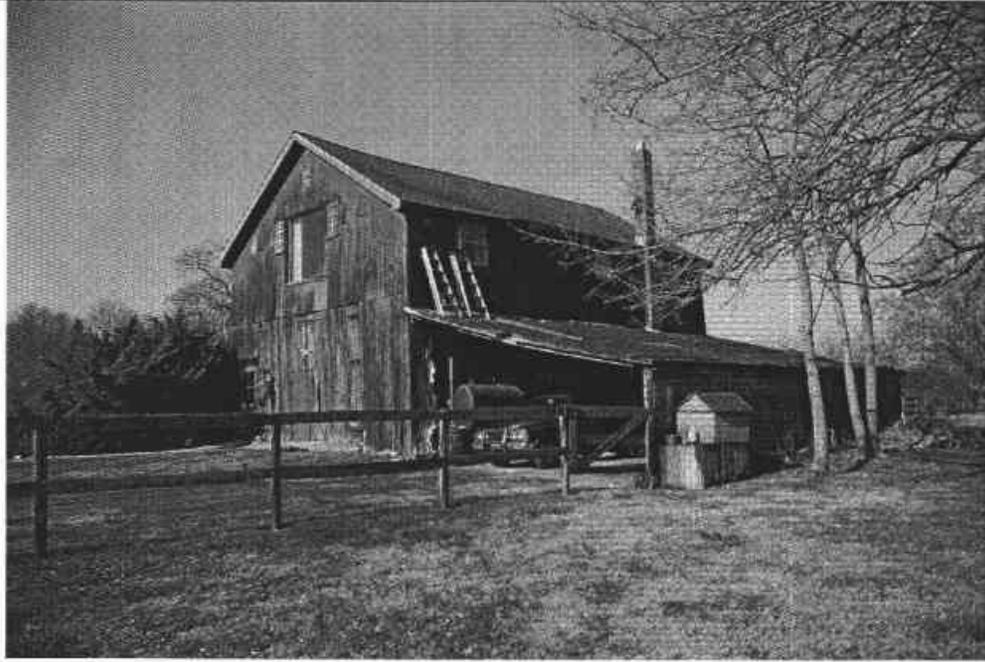
N00121. Photograph 9: Corncrib/Granary, 4677 Summit Bridge Road, south and east elevations, view facing northwest. Note the modern picture window underneath gable.

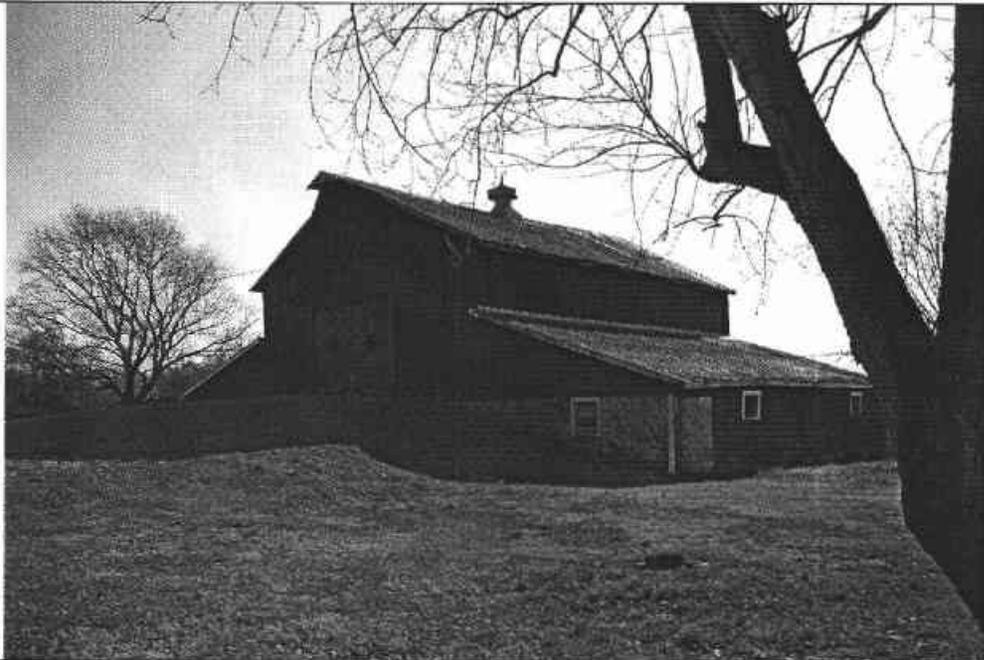
N00121. Photograph 10: Gable front bank barn, 4677 Summit Bridge Road, north and west elevations, view facing southeast. Note the enclosed stable additions off of west and east elevations. Note earthen ramp, hay hood on gable peak, and vent on center of roof ridge.

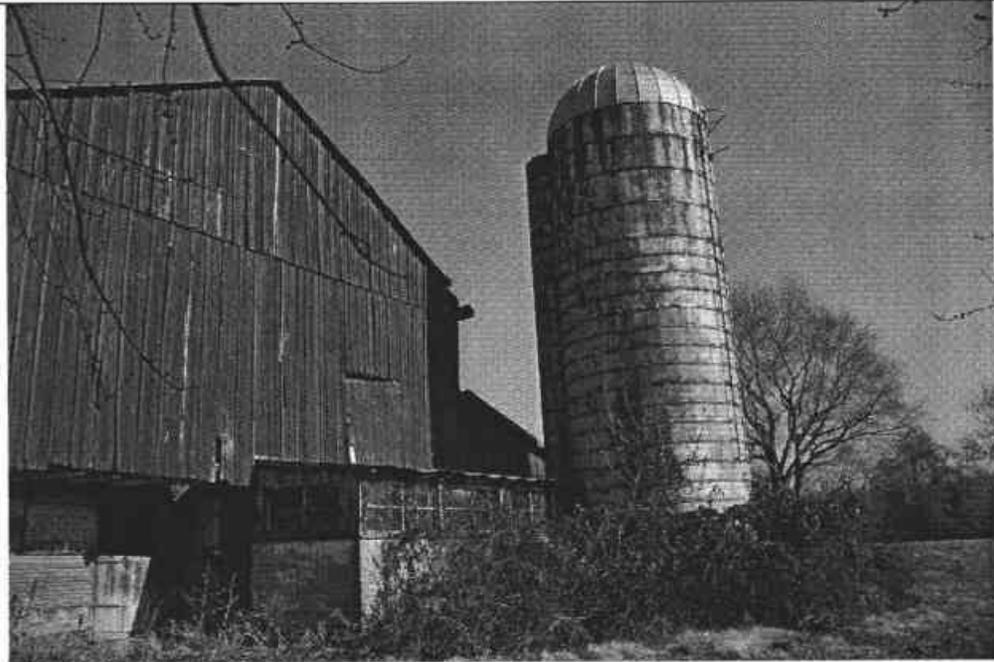
N00121. Photograph 11: Gable front bank barn and silo, 4677 Summit Bridge Road, south elevation, view facing northeast. Note the barn's forebay and milkhouse addition.

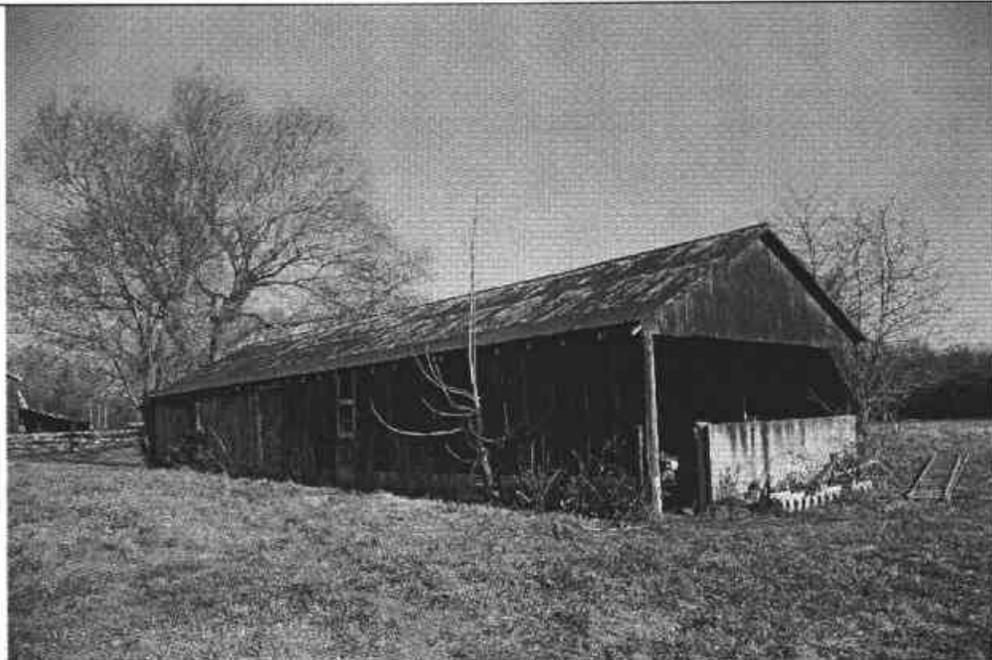
N00121. Photograph 12: Calf barn, 4677 Summit Bridge Road, south and west elevations, view facing northeast.

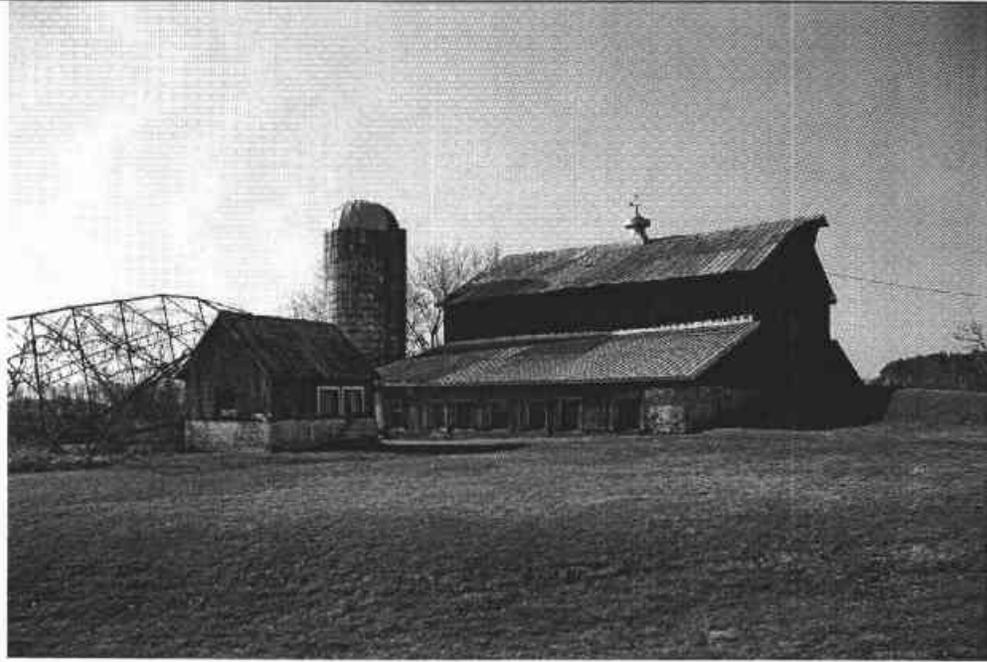
N00121. Photograph 13: Barn complex, 4677 Summit Bridge Road, view facing southwest. Note ruins of windmill. The milkhouse is located in the foreground, silo, and east enclosed stable wing of bank barn also visible.
