Evaluation of the Performance of Four Catch Basin Inserts in Delaware Urban Applications

Marianne Walch, Randall Cole and Wendy Polasko
Delaware Department of Transportation NPDES Program
P.O. Box 778, Dover, DE 19930

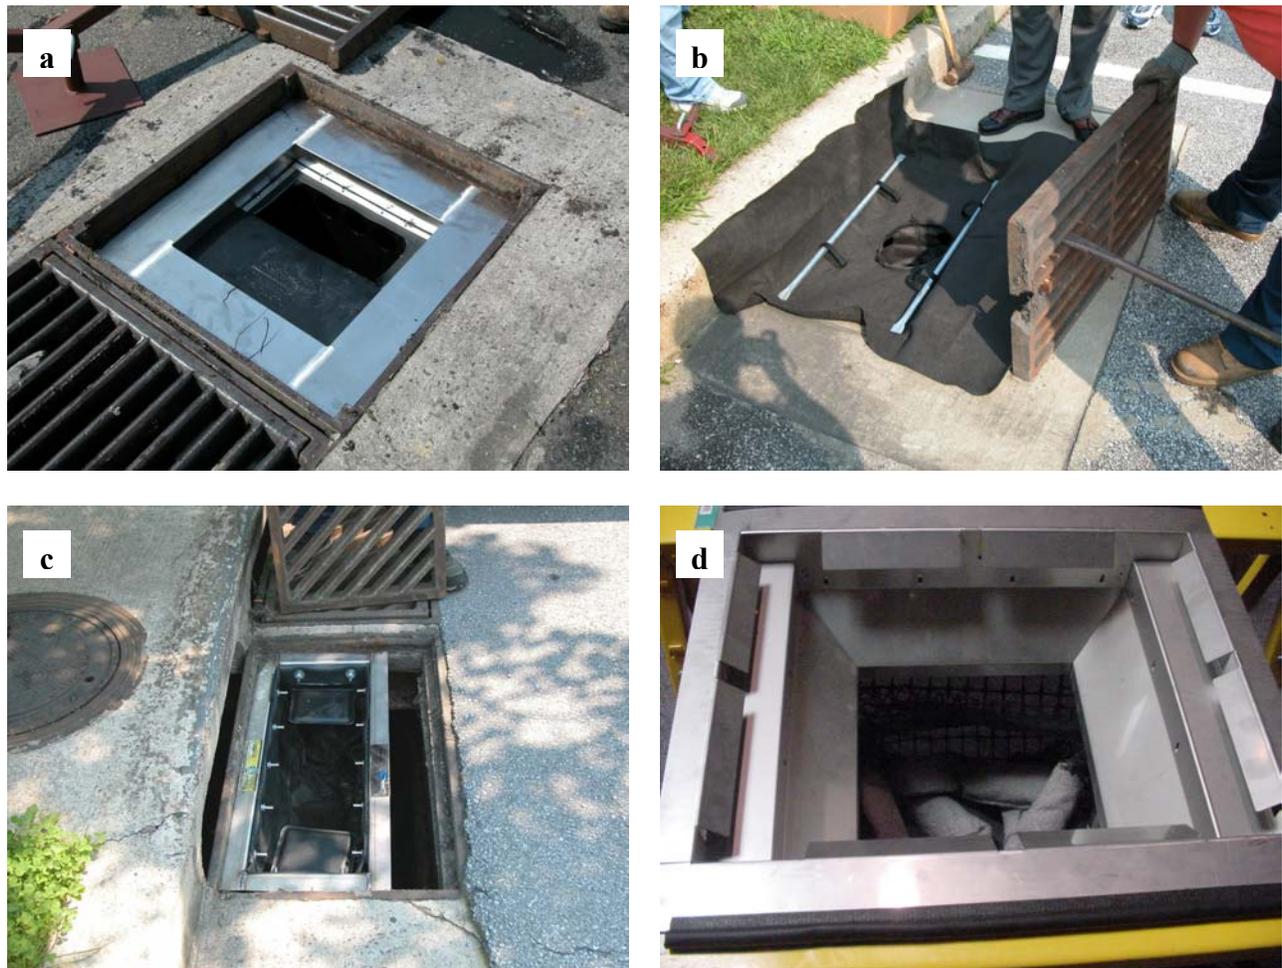
Figure 1. Photographs of installed catch basin inserts. (a) HydroKleen units at the I-95 service plaza; (b) UltraDrainguard filters at the service plaza; (c) DrainPac inserts in Drummond North subdivision; (d) FloGard Plus units at the Wilmington Riverfront.

1. UltraDrainguard[®] Oil and Sediment Model (UltraTech International, Inc.) – an X-TEX geotextile sock and skirt that fits the size of the inlet opening.
2. HydroKleen[®] (Hydro Compliance Management, Inc.) – a two-chambered system consisting of a presettling sediment chamber and a filtration chamber containing one activated carbon and two cellulose filters.
3. DrainPac[®] (United Stormwater, Inc.) – an HDPE support basket and polypropylene filter liner custom-sized to fit the inlet.
4. Flo-Gard+Plus[®] (Kristar Enterprises, Inc.) – a support basket and removable polypropylene filter liner, plus a silicate oil-adsorbent filter medium in floatable bags.

The devices were installed in three different locations, with different land use types and varying pollutant loads. These include the service station drainage areas of a rest area on Interstate Rt. 95 near Newark; Drummond North, a residential subdivision in Newark; and a commercial parking area on the Wilmington Riverfront (Table 1). Photographs of each insert are included in Figure 1.

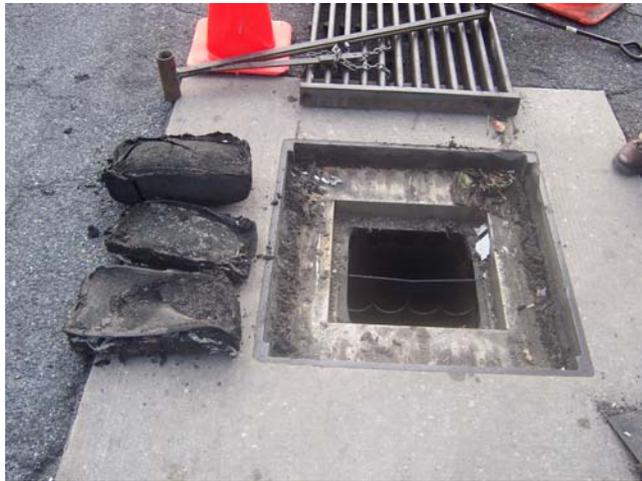
Figure 2. Used cellulose (front) and activated carbon (back) filters removed from HydroKleen inserts after nine months service

The filters were replaced immediately before water quality sampling began, after about nine months of service. The originally white cellulose filters were thoroughly blackened, indicating that the media was saturated with adsorbed hydrocarbons (Figure 2). Little sediment had accumulated in the sedimentation chambers of the inserts; even after nine months most of the chambers had less than an inch of sediment in them. It is not clear whether this is due primarily to a very low sediment and debris load coming from this part of the service plaza or to resuspension and failure to collect the sediment that does enter the units.

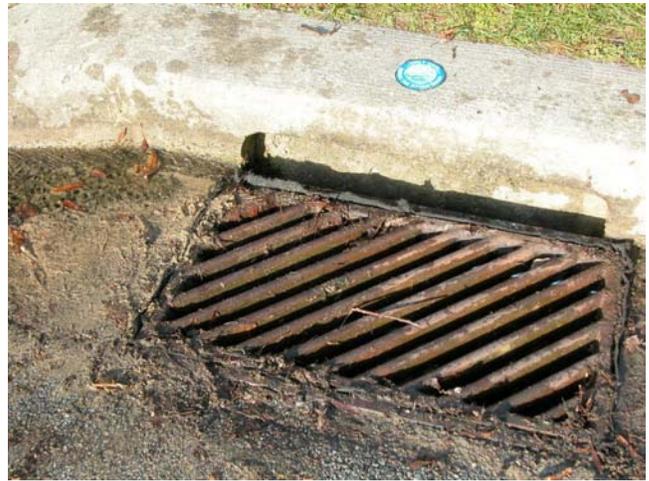
Figure 3. UltraDrainguard-protected inlet showing water flow bypassing the filter and entering the curb opening

Wet weather data from the DrainPac[®]-protected catch basins have been highly variable (Table 2). Concentrations of most parameters measured in first flush samples collected from the protected run of inlets were frequently higher than in samples from the untreated control (Table 2). This difference, however, generally was not statistically significant (Wilcoxon signed rank test, $p > 0.05$). Contaminant concentrations in composite samples also were not significantly different between treated and control runs. The lack of difference in this case may be explained by the observation that much of the water flowing into the catch basins appears to bypass the DrainPac[®] filters. The catch basins in this community, like many in Delaware, are grated curb inlets (Figure 3), and, because in our trial the

DrainPac[®] units do not extend under the curb opening, water that flows into the curb opening does not get treated. For this type of inlet it is clearly desirable to have a BMP that extends under this opening in order that most of the water is not bypassed.

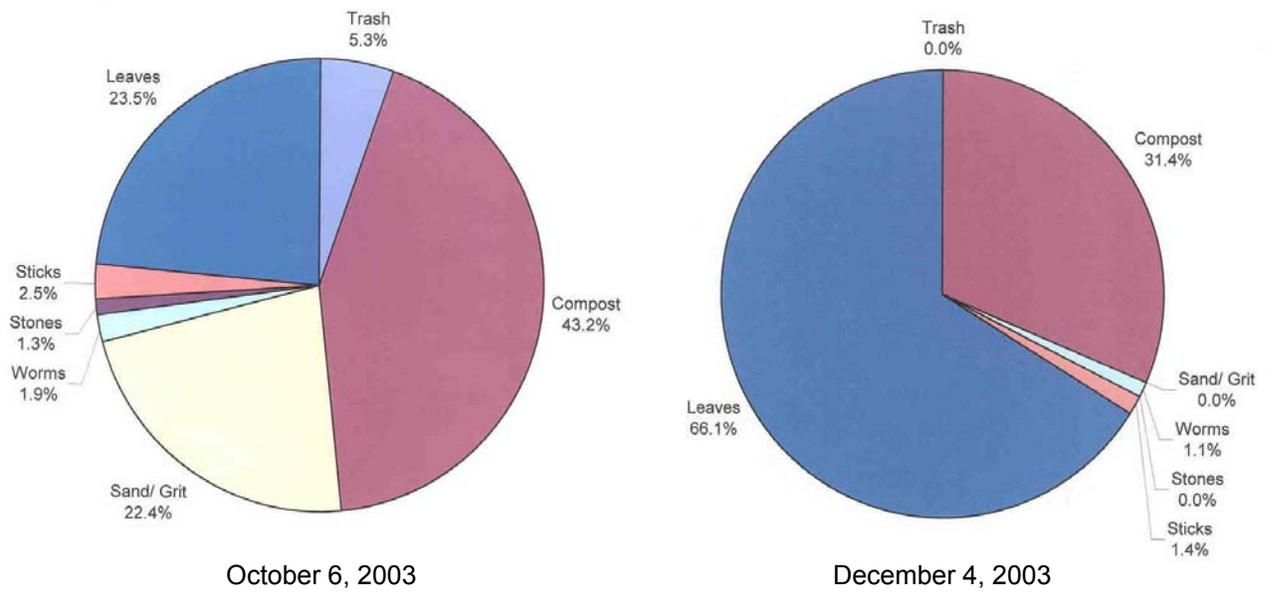
Figure 4. Mean percent volume of contents removed from DrainPac filter bags at two different times, showing the preponderance of leaves and other organic debris.

The DrainPac[®] units, despite the relatively large size of the filter bag, filled up rapidly in this tree-lined community, particularly during the autumn leaf fall (Figure 4). They were cleaned at two-month intervals. However, in this case the units should probably be cleaned more often to prevent resuspension of the collected debris, which may also have contributed to the lack of observed difference in treated and untreated contaminant concentrations. Stenstrom (1999) also demonstrated that DrainPac inserts bypassed much flow once they had accumulated debris.
